Templeton-Whitney Grazing Allotments, Golden Trout Wilderness

Head Cut and Photo Point Monitoring, 2003 and 2010 (DRAFT)

By: Casey Shannon, Hydrologic Technician

Inyo National Forest, Supervisor's Office

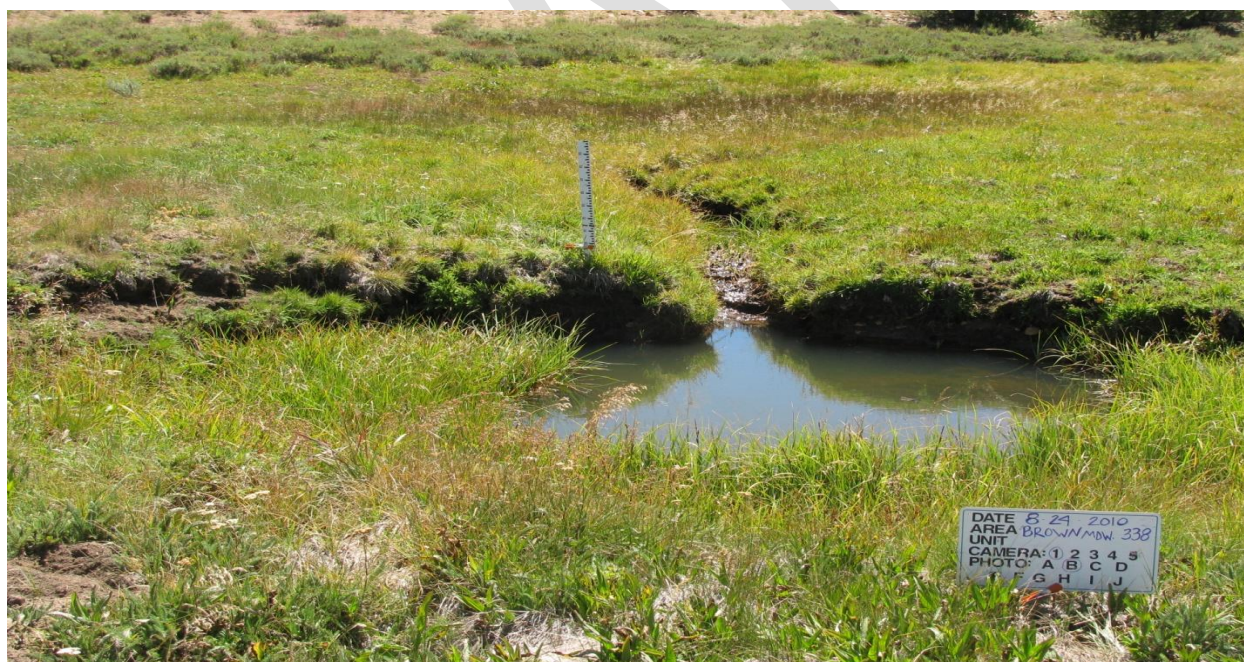
Above photo: Photo-point 338 (PP-338) Brown Meadow, July 2003. Site has an eroding scour pool with a small head cut and eroding banks. **Below photo:** PP-338 Brown Meadow with photo re-taken August 2010. Not a lot of noticeable change. Banks have started to stabilize with new vegetation. The scour pool has become larger and the surrounding banks are bare and slightly more unstable than in 2003. The HC has migrated only 0.50 meters. The site over time should find equilibrium and stabilize, but it still vulnerable to outside disturbance that may continue instability.

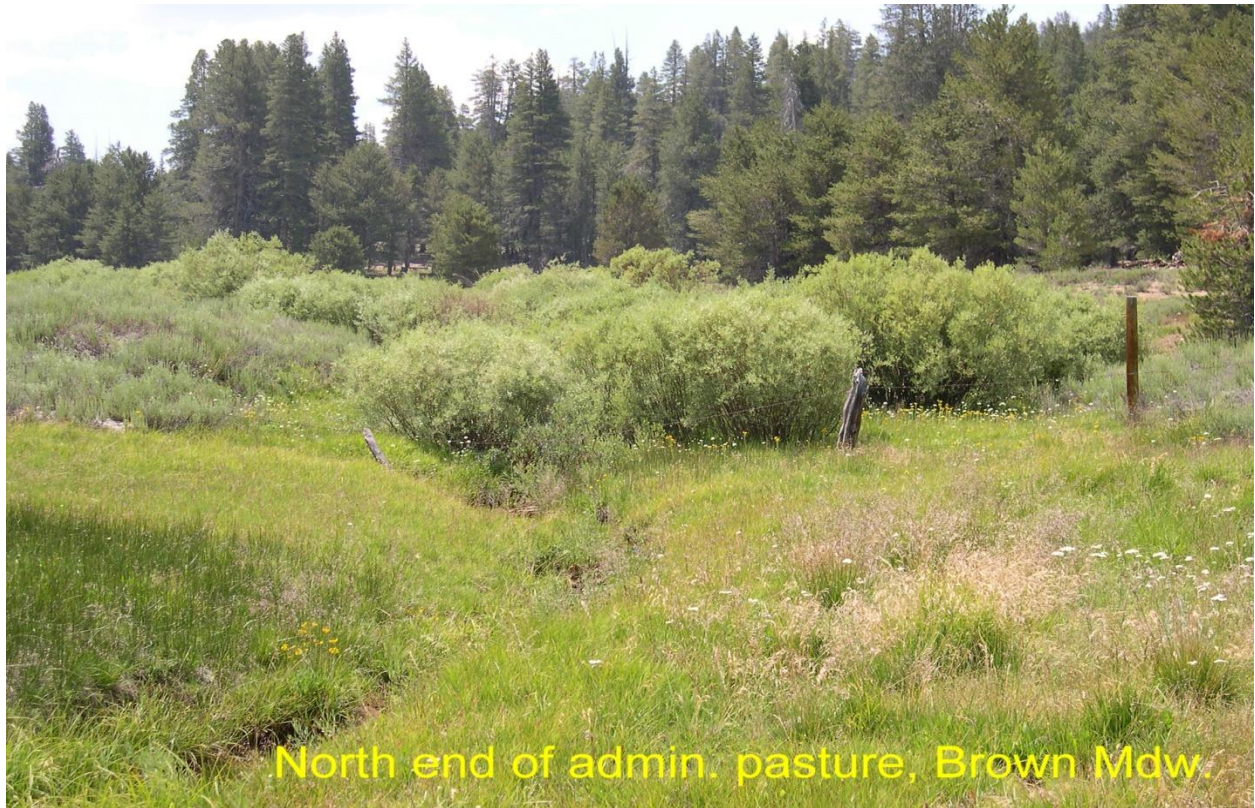
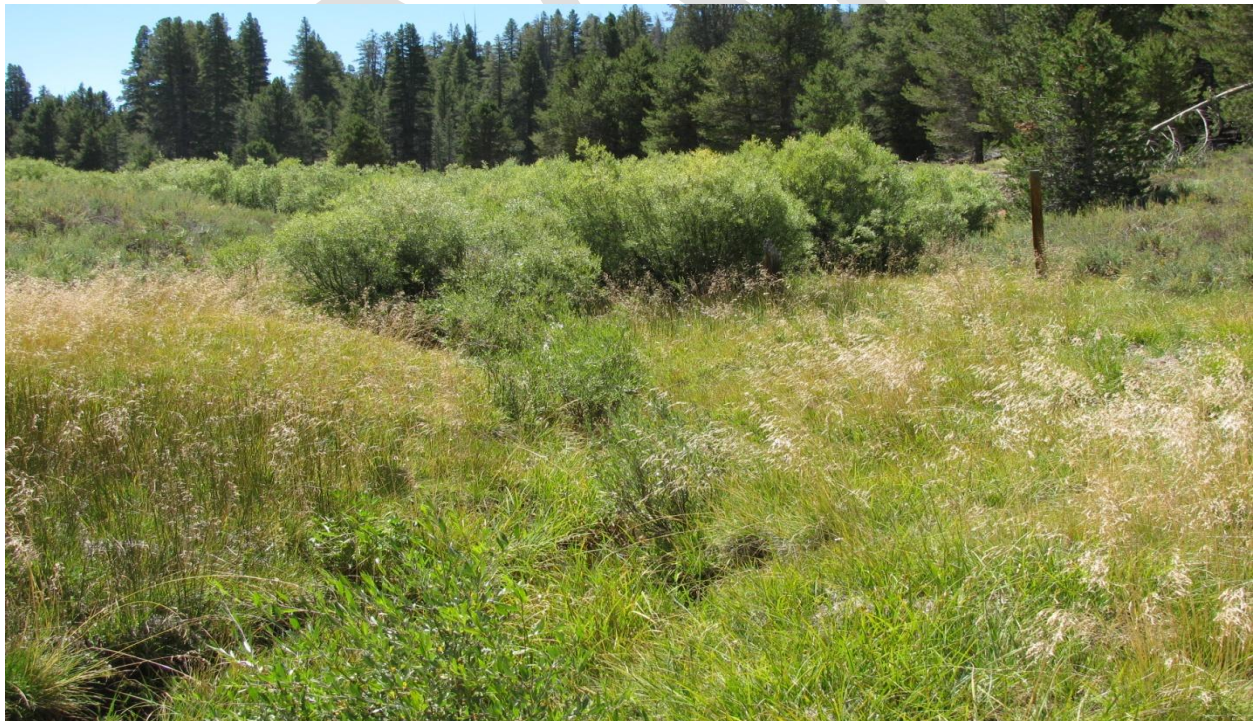
Above photo: Reference photo only, not an established photo point. View is looking at riparian vegetation along Brown Creek at the Administrative Pasture near the cow camp at the northern boundary, photo taken July 2003.

Below photo: Same site with photo re-taken August 2010. Riparian vegetation has filled in and willow growth increased, adding to overall meadow stability at this site.

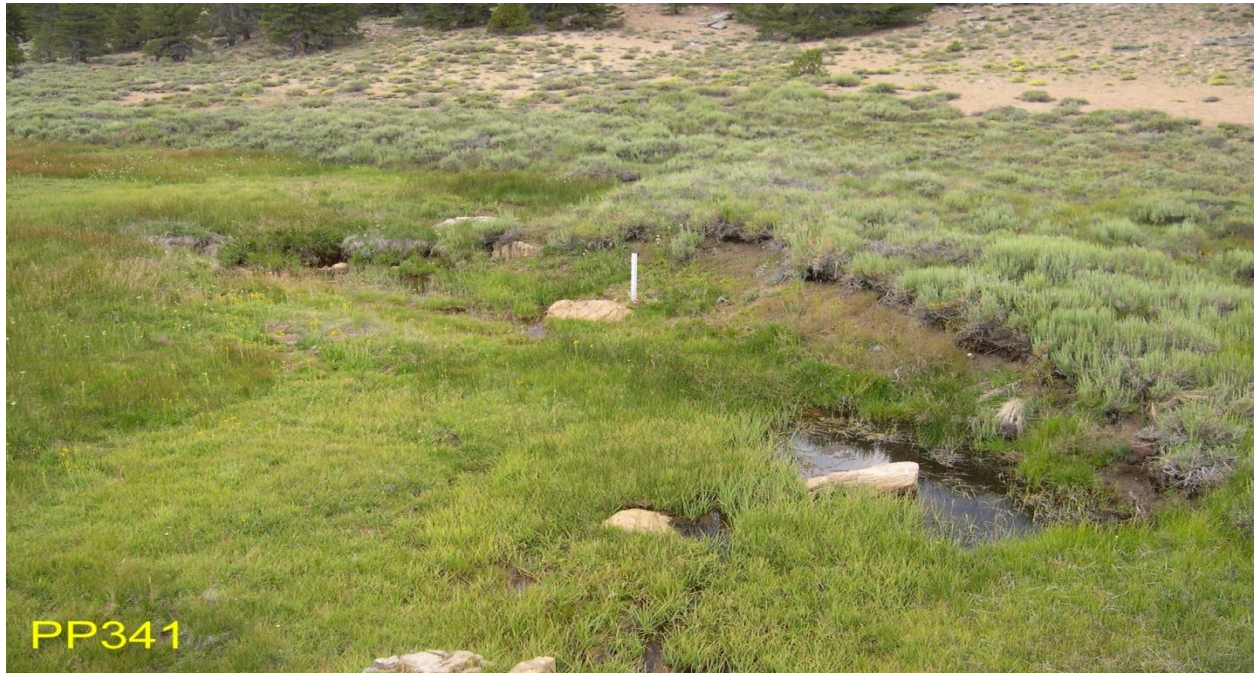
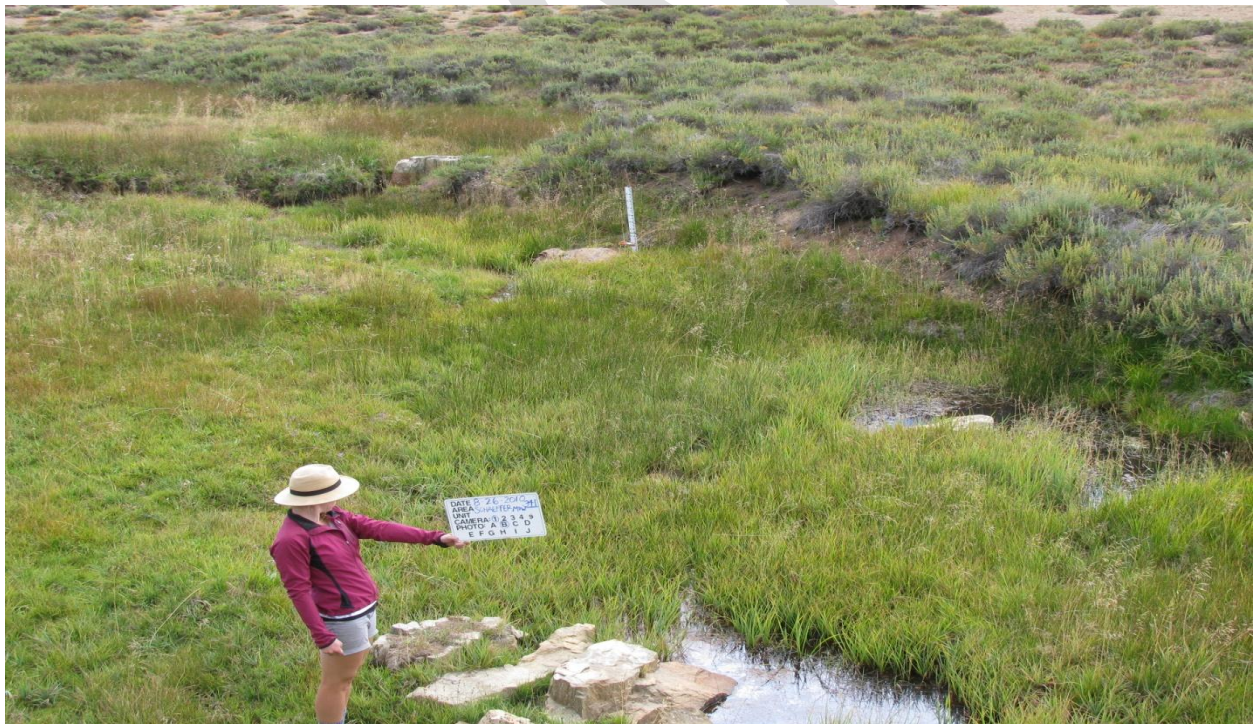
Above photo: Photo point 341 (PP-341), Schaeffer Meadow, July 2003. Terrace banks along stream are mostly bare of vegetation within historic incised channel. **Below photo:** PP-341 Schaeffer Meadow photo re-taken August 2010. Channel bottom has slightly aggraded with soil and vegetation along with elevated water table. Vegetative cover is now moving up the terrace banks and starting to stabilize bare soil area. Soils are wet and terrace banks are still vulnerable to disturbance, although more resilient than in 2003.

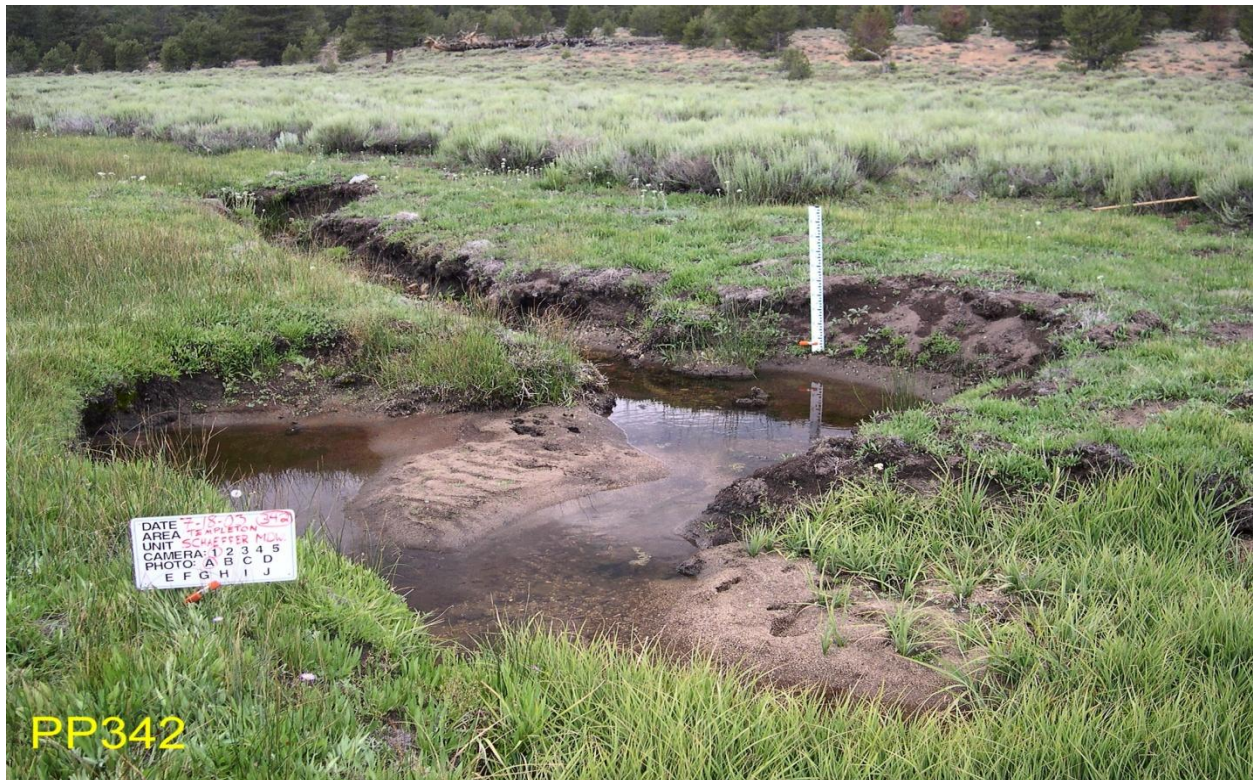
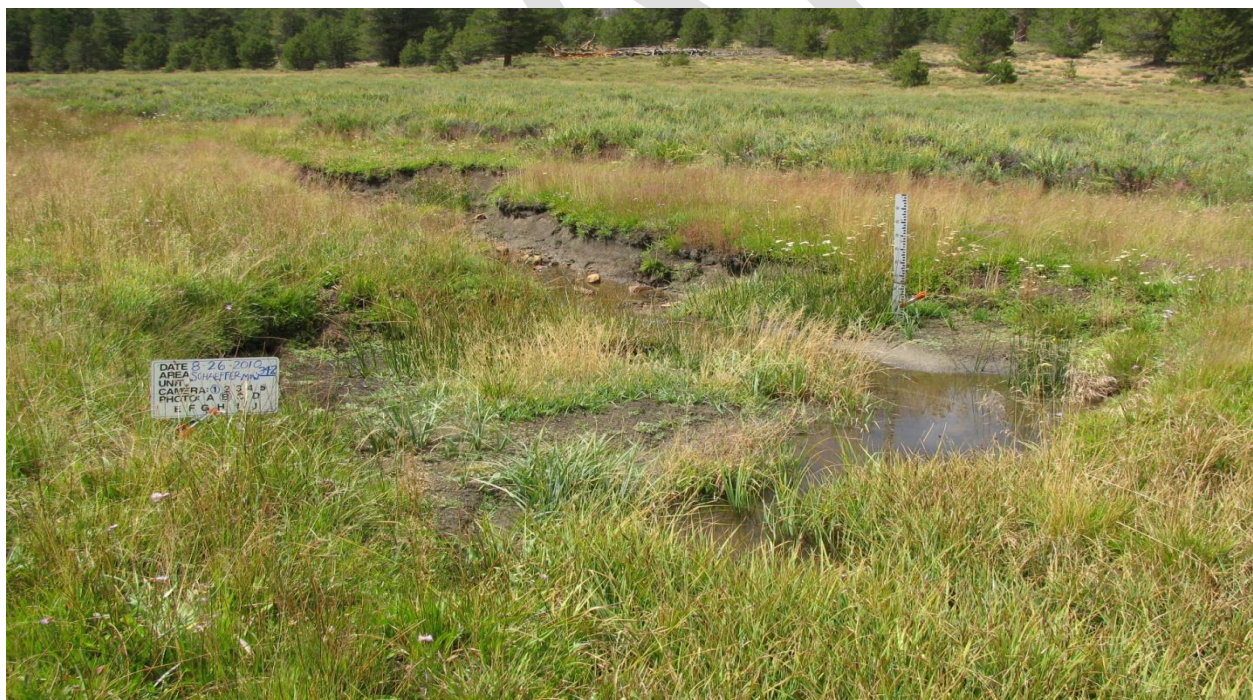
Above photo: Schaeffer Meadow photo-point 342, taken July 2003. In-channel focus is on bare, unstable stream banks and soil. An active head cut exists 9 meters upstream of site. **Below photo:** Photo-point 342 re-taken August 2010. Point bar in foreground has increased vegetation and adjacent stream banks also since 2003 and overall vegetative stability has increased. Still vulnerable to erosion is the gully above that is well scoured and bare from recent high flows and an active head cut is still migrating upstream. Even with moderate recovery this site is still at risk from disturbance.

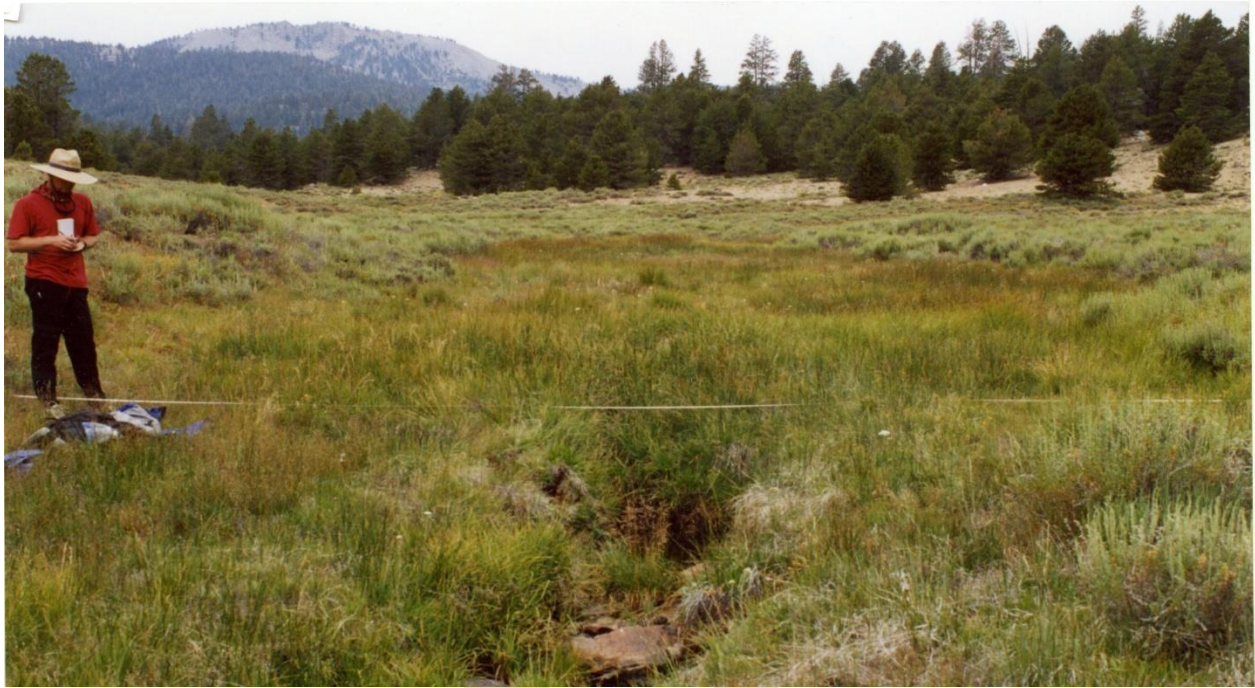
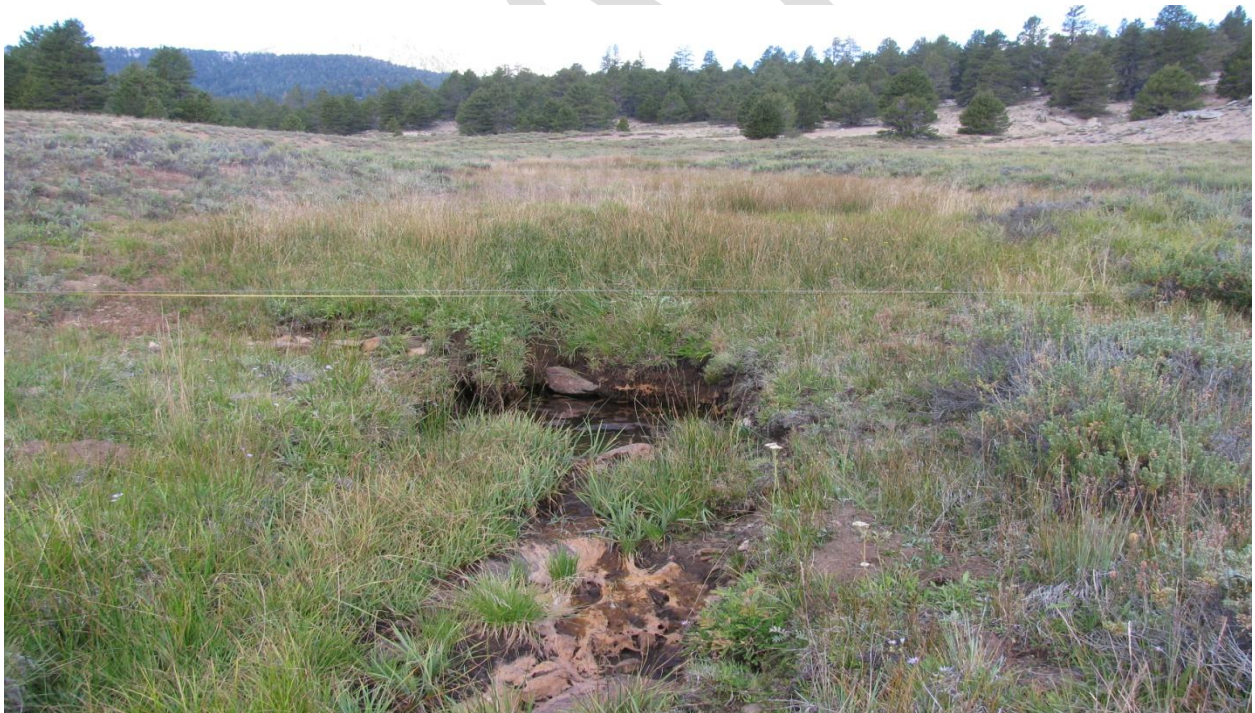
Above photo: Head cut 339 (HC 339) lower Schaeffer Meadow, July 2003. Medium size head cut migrating into strongly vegetated floodplain. Gradient at this point starts to increase. Sub soil at this site is rocky, sand and silt. **Below photo:** HC 339, lower Schaeffer Meadow photo was re taken August, 2010. Head cut has migrated only 0.55 meters but has steepened, widened and incised below. Head cut is more exposed and susceptible to additional erosion. Strong vegetation and rocky subsoil helps to slow HC migration at this site.

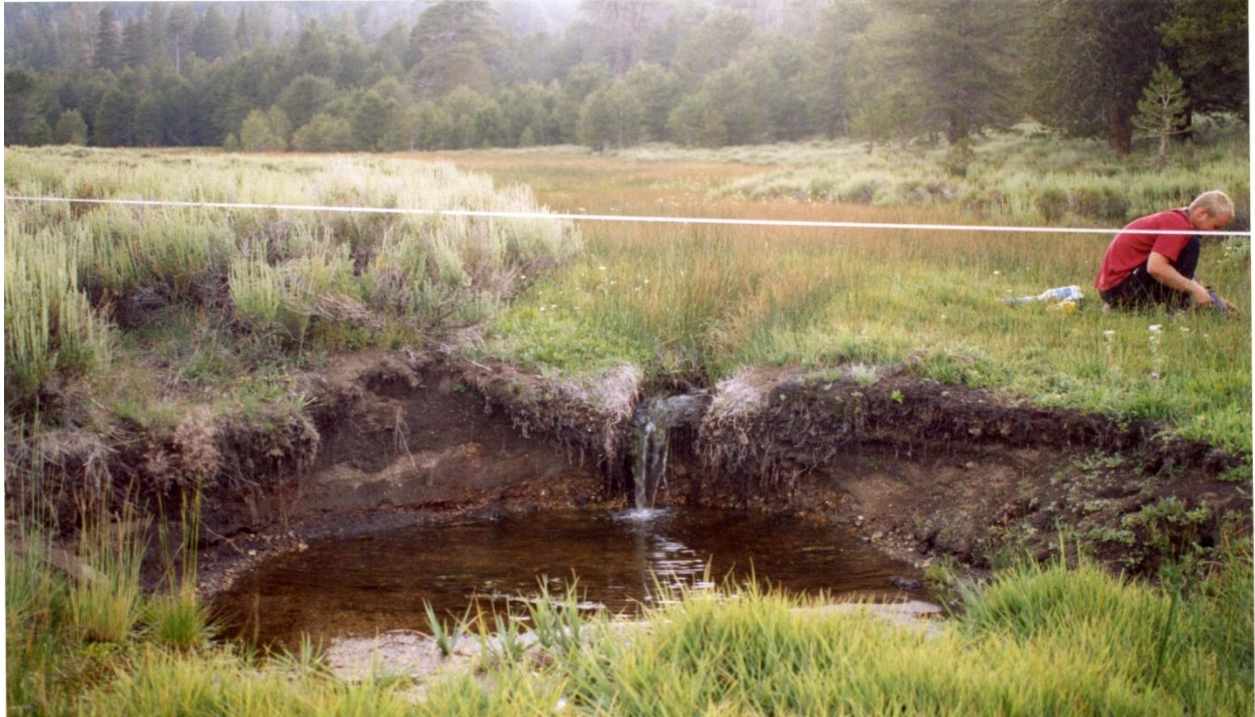
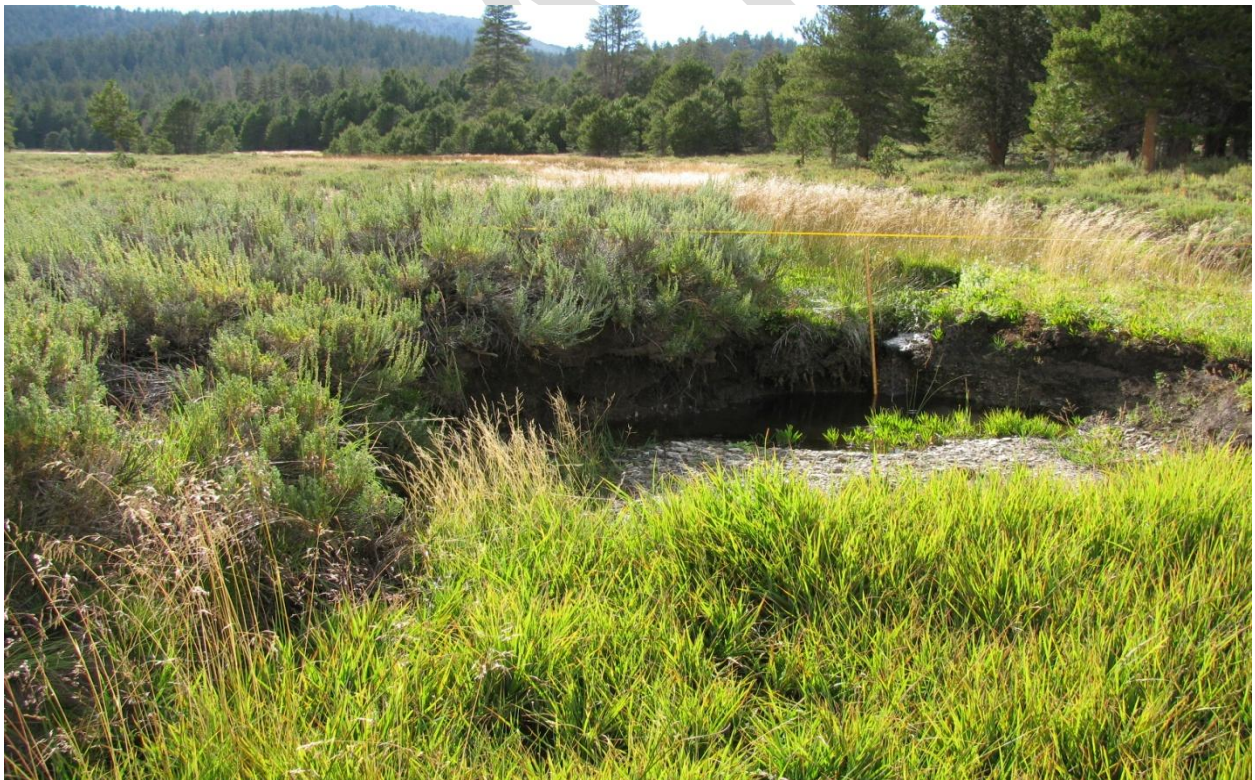
Above photo: Head cut 344 Upper Schaeffer Meadow, July 2003. A very large, scallop type HC with eroding face. No gully below. **Below photo:** HC 344 Upper Schaeffer Meadow, with photo re taken August, 2003. HC has slowly migrated (0.95 meters) and has widened in extent since 2003. Strong vegetation and dense organic layers in substrate slows migration rate. Photo of same site was taken in July 1997. Floodplain in channel below HC is recovering and robust.

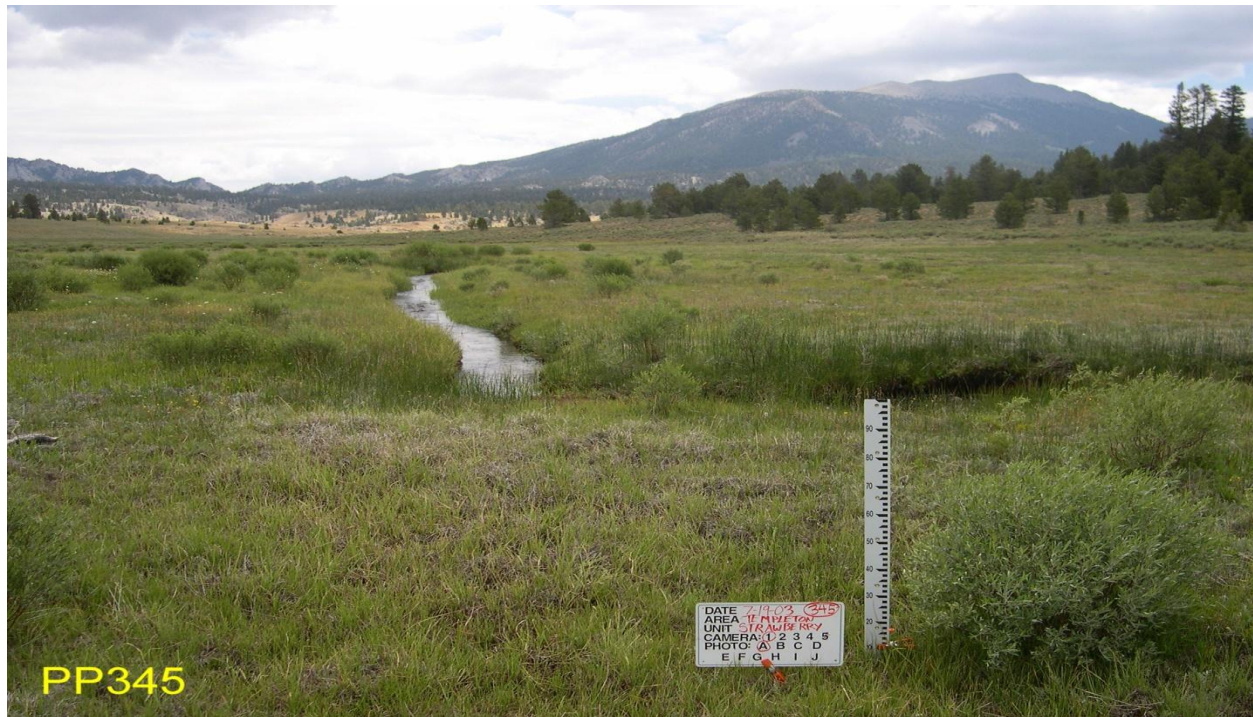
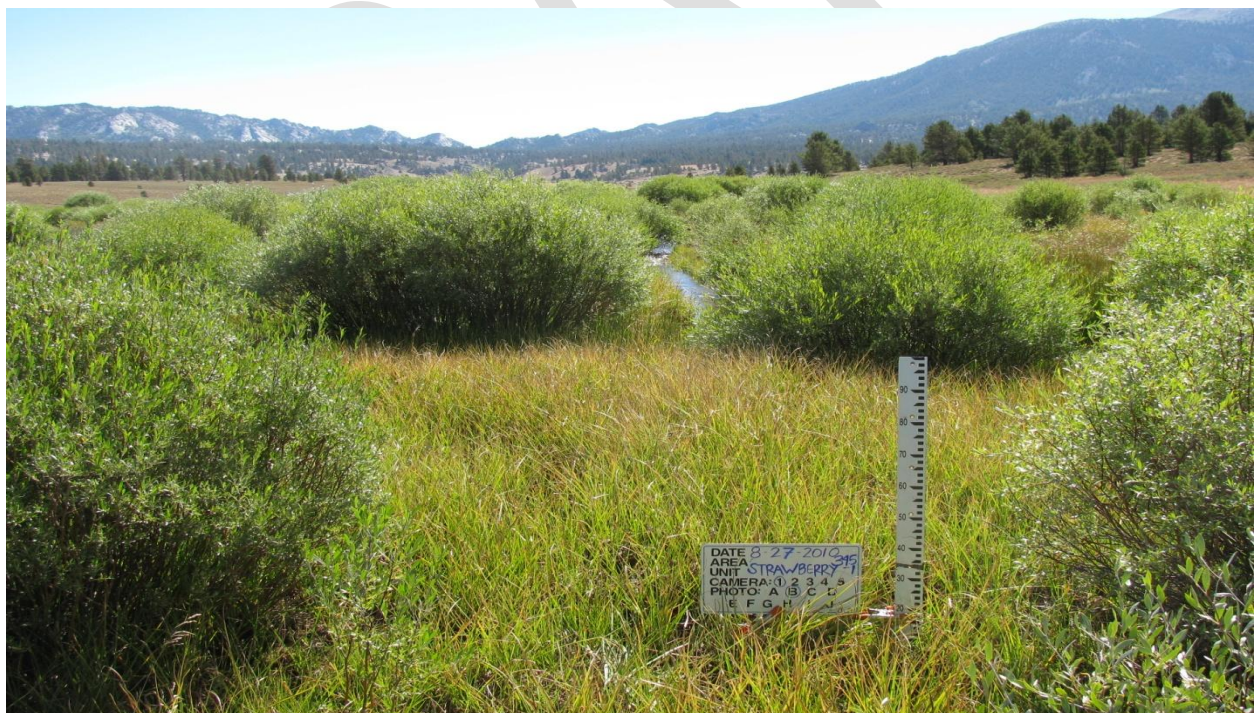
Above photo: Photo-point 345 1-A, Strawberry Meadow looking east down creek, July 2003. Willows and other riparian vegetation showing recovery three years after grazing was rested. **Below photo:** Same site with photo retaken August 2010. Willow and sedge growth has significantly increased and the stream channel and banks are stable along this reach, a productive site. Soils are wet within this area as the stream is able to access floodplain during average peak flows and ground water is shallow, deep organic soil exists.

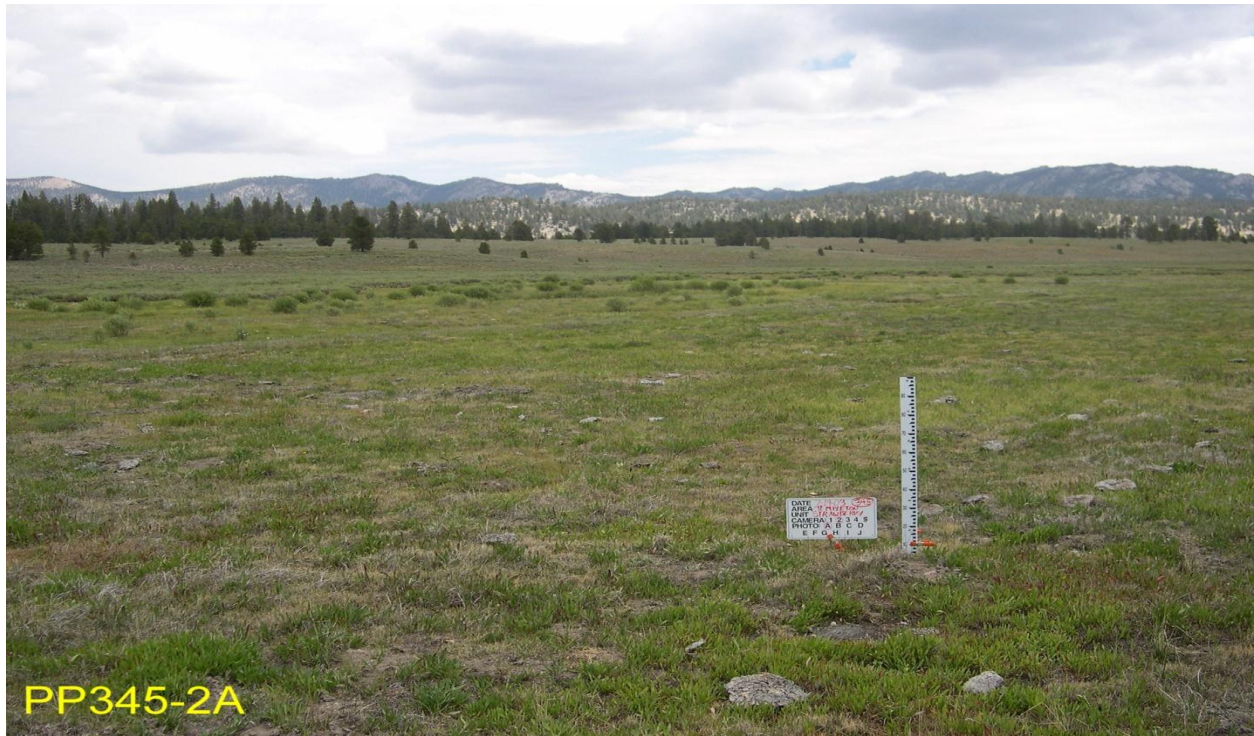
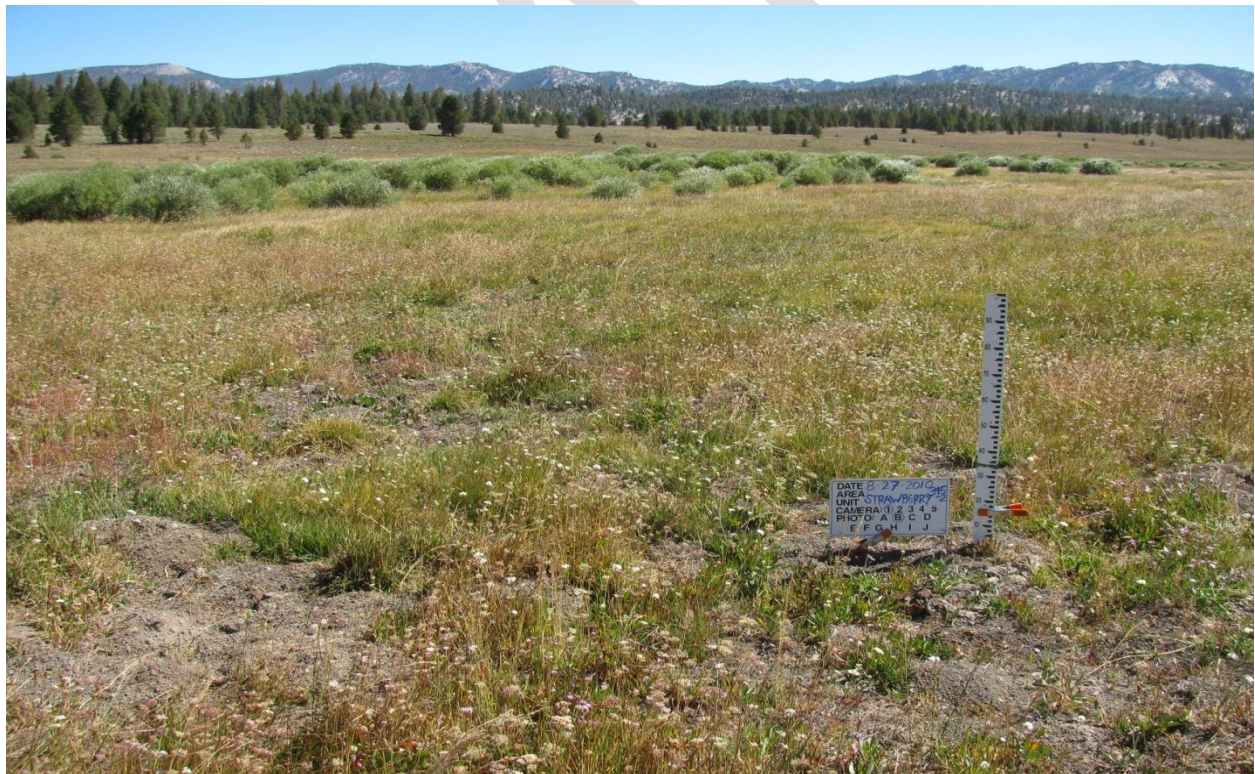
Above photo: Photo-point 345-2A, Strawberry Meadow July 2003. Willow growth along Strawberry Creek is showing signs of recovery along with sod cover. This was a grazing key area of use in Strawberry Meadow.

Below photo: Same site with photo retaken August 2010. Willow development has significantly increased in vigor and numbers (along creek) and overall sod cover has improved, with the exception of rodent disturbance creating pockets of bare and disturbed soil as seen in foreground.

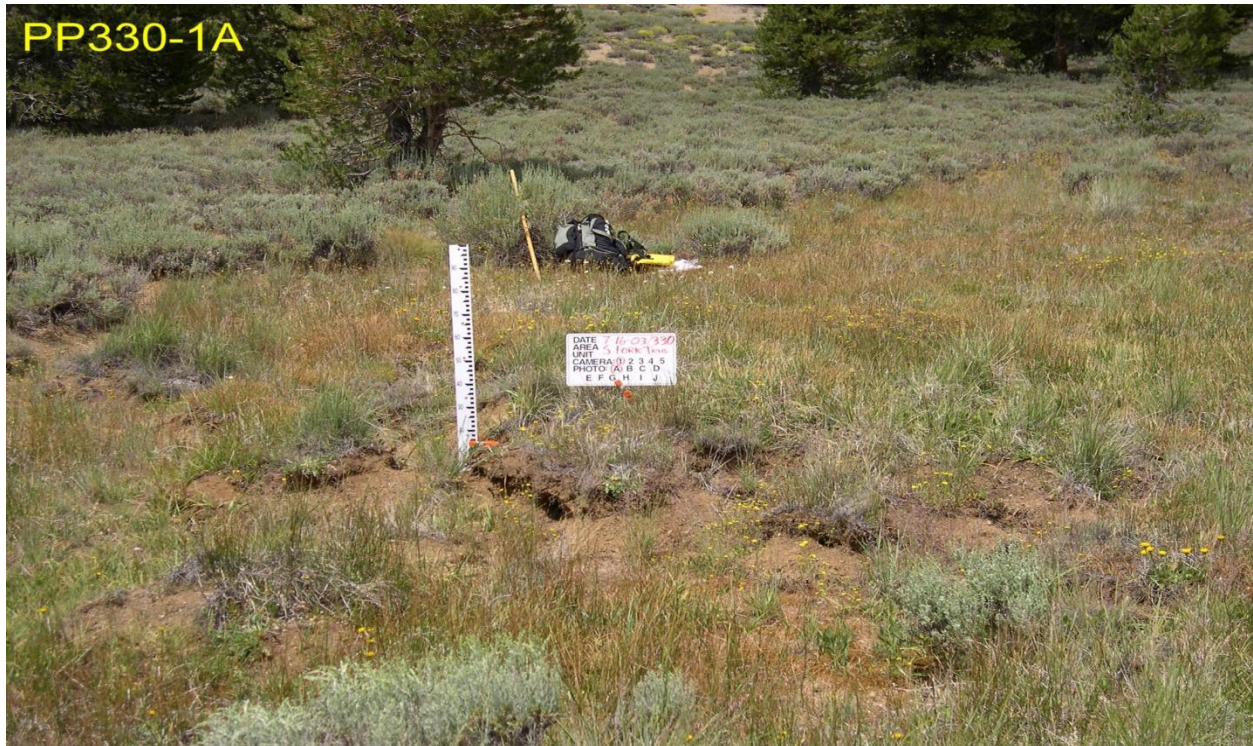
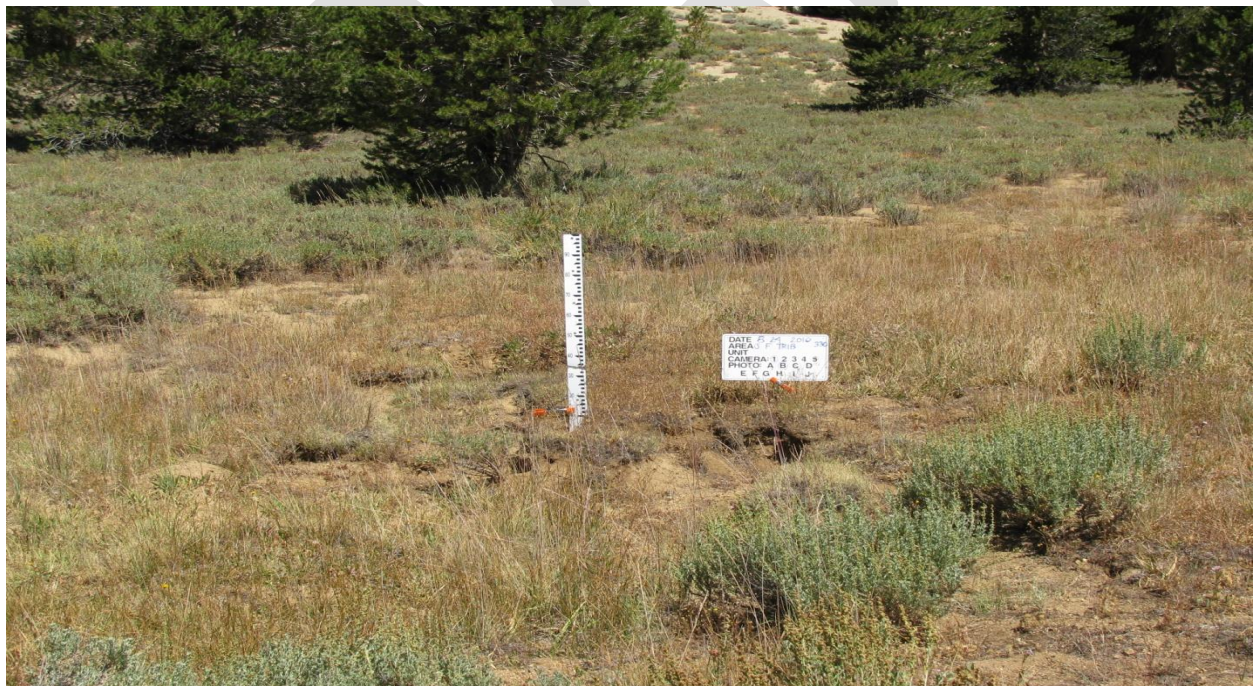
Above photo: Taken July 2003, Photo-point 330, South Fork Tributary meadow ½ of a mile NW of Brown Meadow. Site is a small area of disturbed sod with various nick points and bare soil, mostly well drained with a shallow organic layer and southern aspect tends to dry easily. **Below photo:** Same site with photo retaken August 2010. Vegetative cover and stability has moderately increased and erosion has slowed. However, bare nick points are still vulnerable to erosion. Slow recovery site.

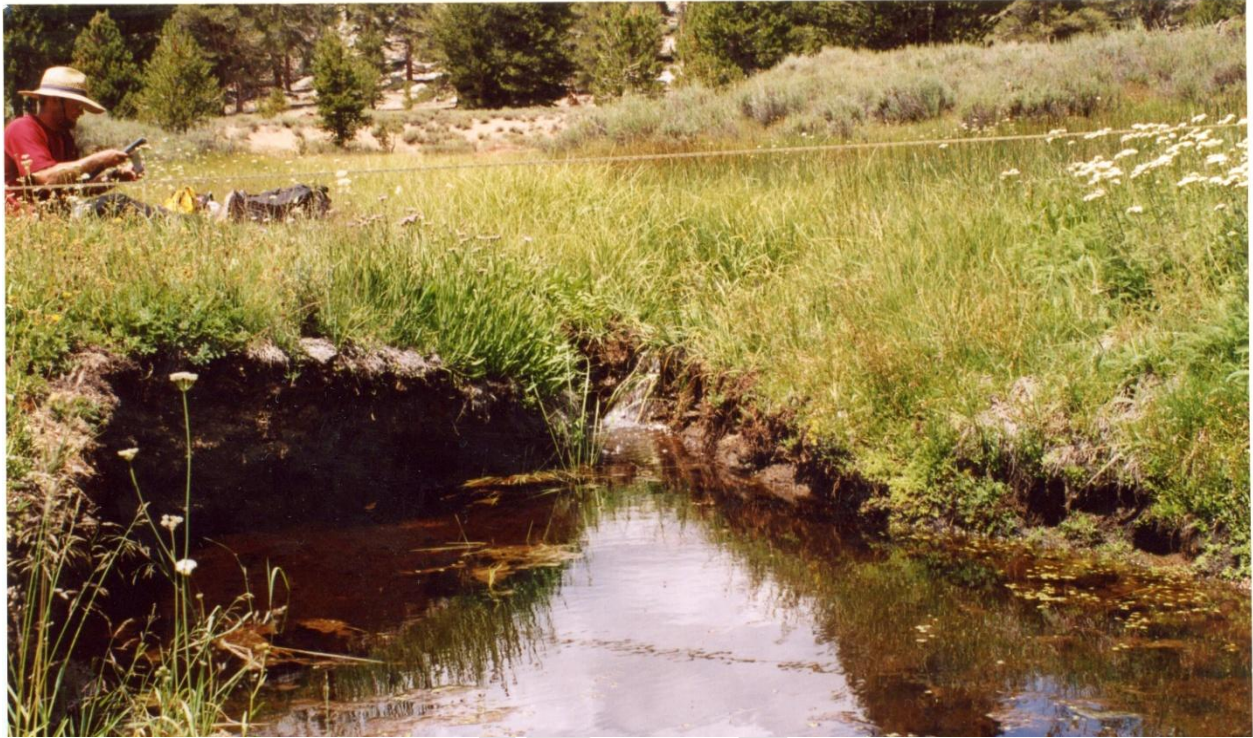
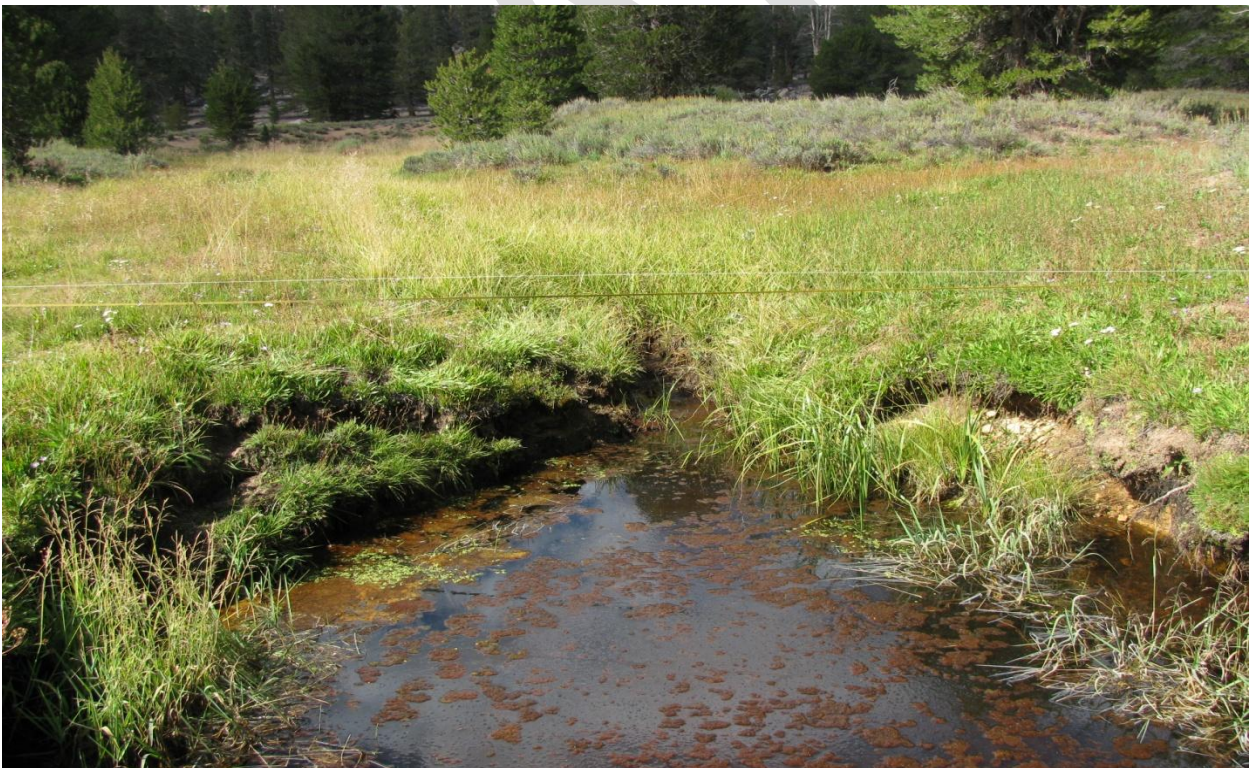
Above photo: Head cut 351 (HC 351) Death Canyon Creek, July 2003. Wide scour pool below HC with exposed sod banks. Deep, well-rooted organic soil horizon and robust riparian vegetation exist at site. **Below photo:** HC 351 Death Canyon Creek with photo re taken August 2010. Scour pool at HC 351 has widened and lengthened as sod banks have started to unravel and balance. Deep organic horizon and robust vegetation has slowed HC migration, HC has migrated only 2.22 meters. Floodplain above HC is stable and intact.

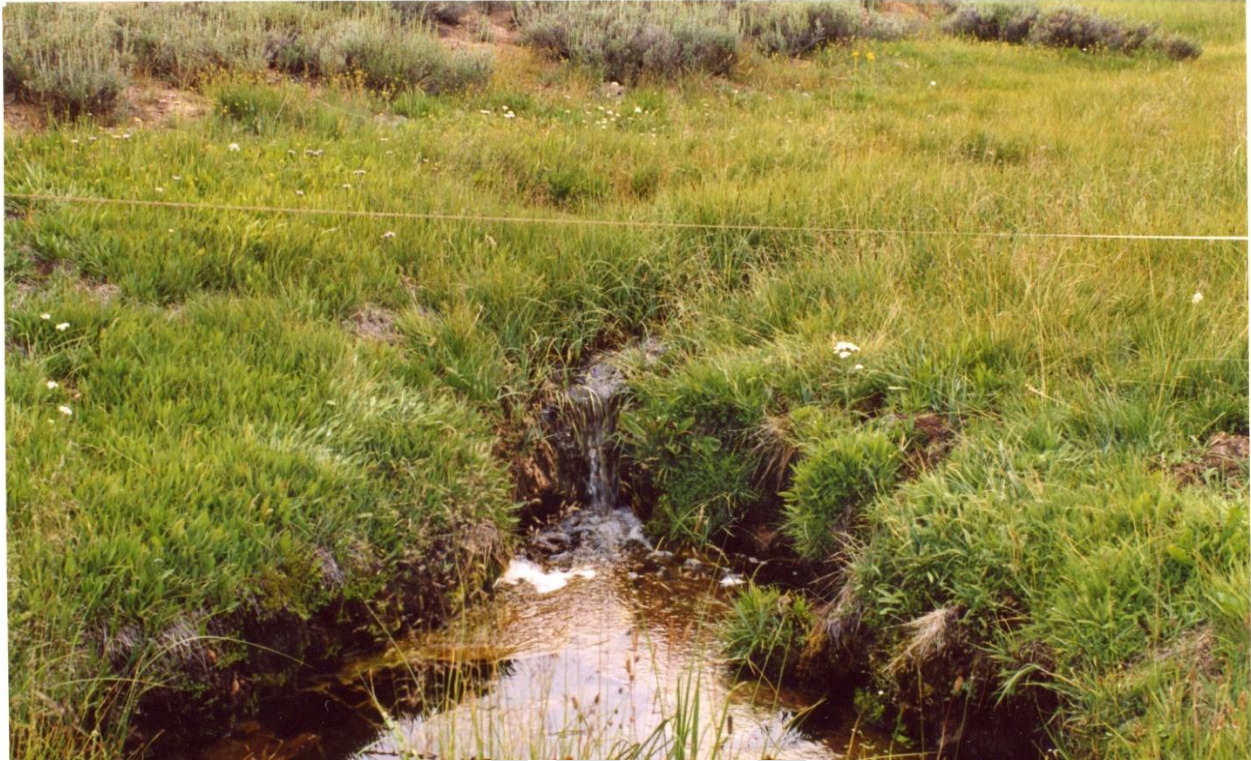
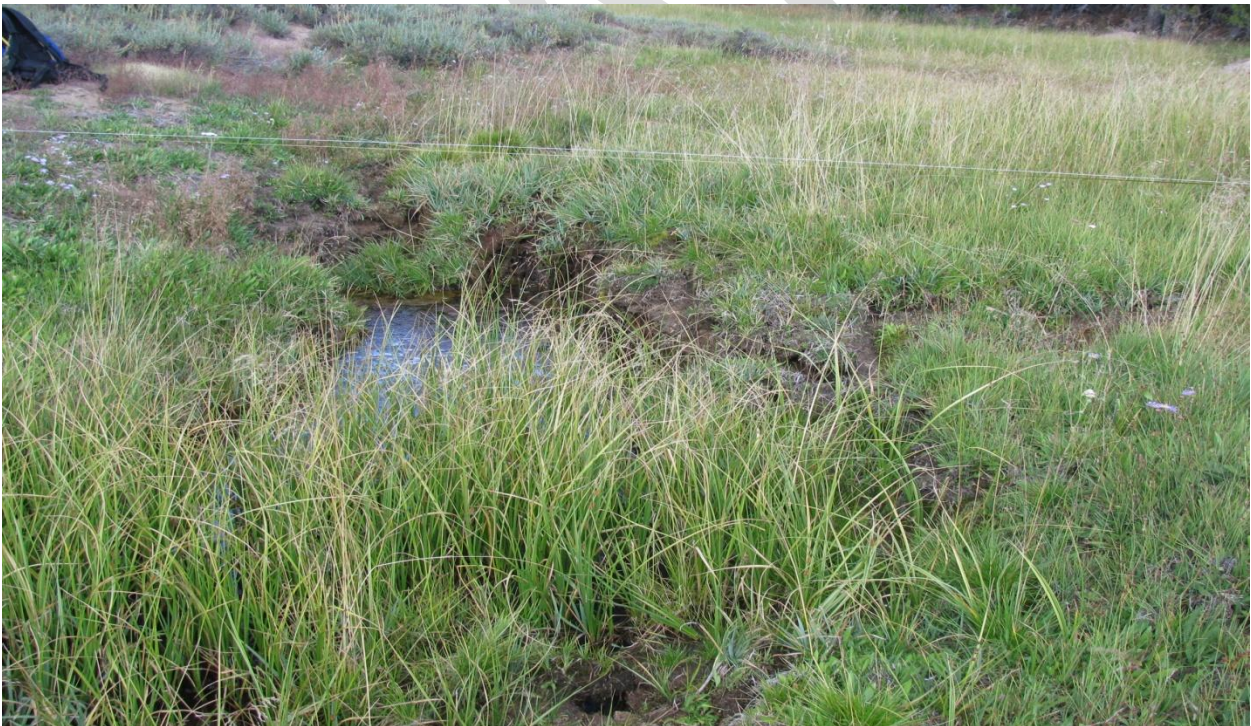
Above photo: Head cut 350 (HC 350) Death Canyon Creek, July 2003. Moderately deep scour pool HC in well developed flood plain, does not have a gully below. **Below photo:** HC 350, Death Canyon Creek with photo re taken August 2010. Head cut has only migrated 1.22 meters since 2003 and a widened area of soil has been removed from erosion. Floodplain vegetation is very strong and robust and dense organic soil layers combined with low gradient are slowing HC migration rate. Floodplain is showing indications of elevating since 2003 as riparian vegetation is further up on terraces. Scour pool below HC is starting to fill in with sedge.

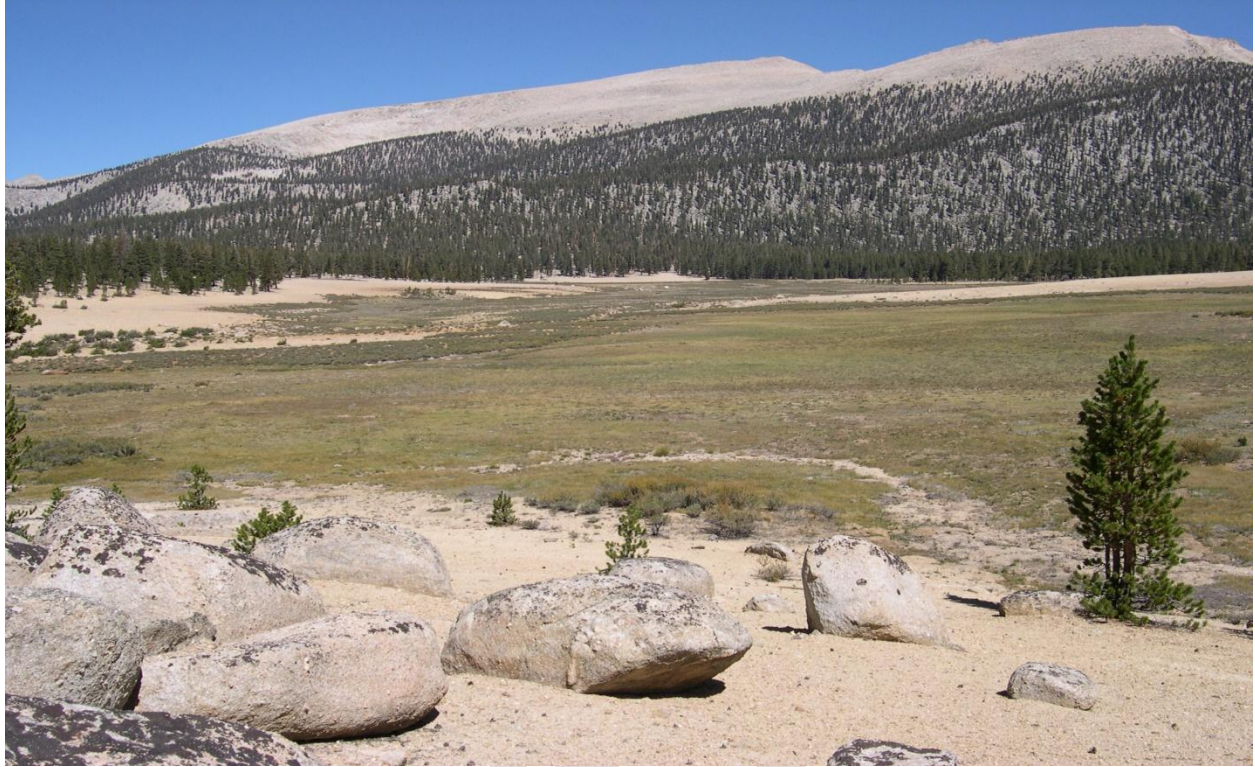
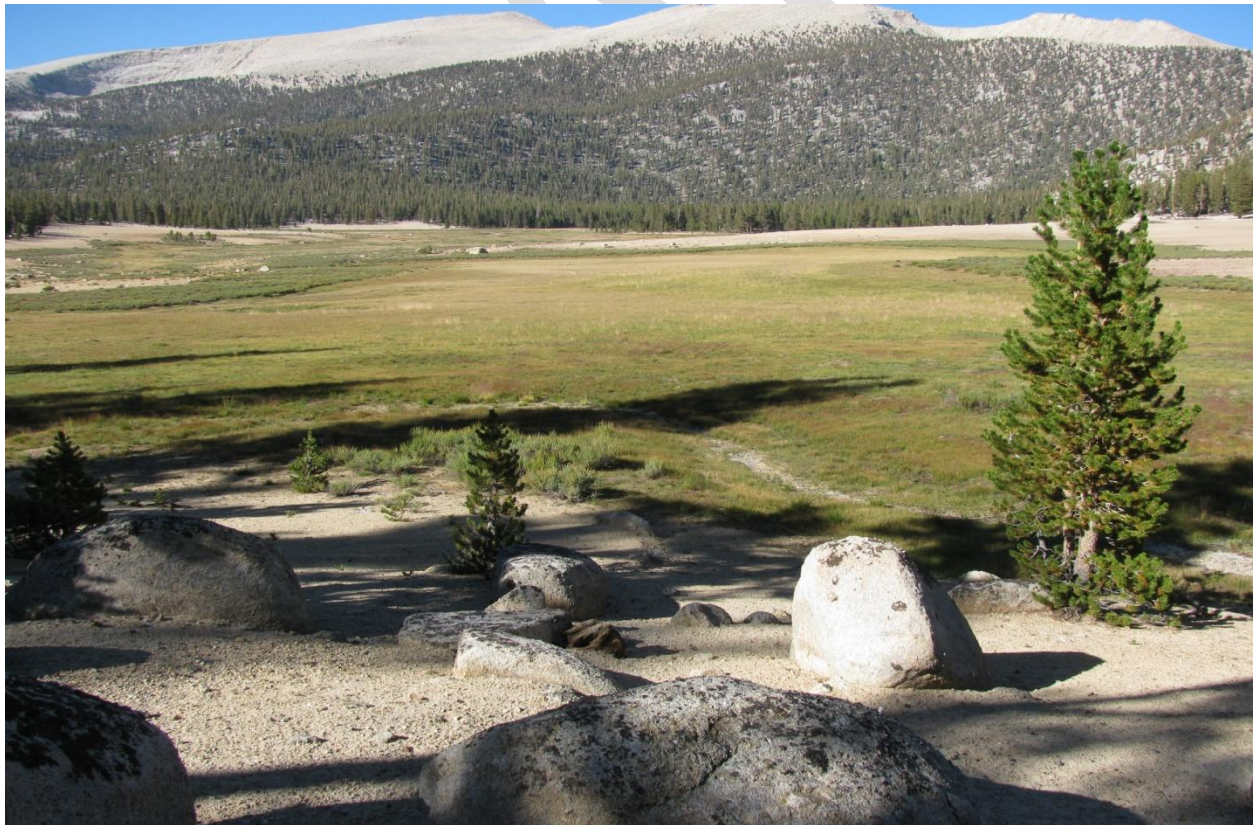
Above photo: Overview of Stokes Stringer, section 1 September 2003. **Below photo:** Overview of Stokes Stringer photo re-taken September 2010. Overall riparian vegetative cover has increased since 2003.
